PITTSFIELD VILLAGE COMDOMINIUMS

Structural Alterations to Roofs and Attics to support solar panel installations 2220 Pittsfield Blvd, Ann Arbor MI 48103

ASSOCIATION CHARGE TO CONSULTANTS

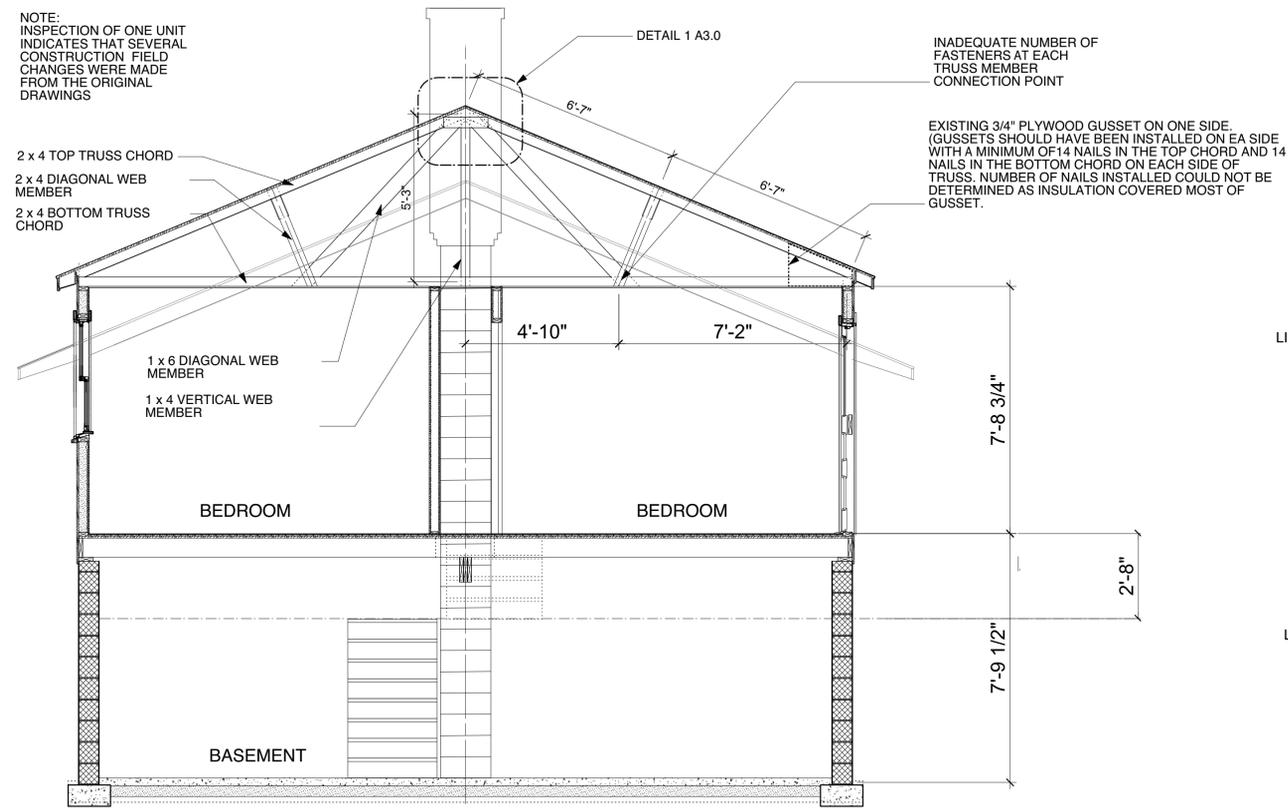
1 EXISTING BUILDING SECTION AT C1-C1
 Scale: 3/8" = 1'-0" on 24" x 36"
 3/16" = 1'-0" on 12" x 36"

3. (Section C1-C1) The bedroom ceiling and roof assembly consists of roof trusses made by overlapping web diagonal members and plywood gusset plates installed on one side of the truss. All connections were hand nailed. Structural analysis of this truss shows insufficient fastening at all truss web member joints. If additional permanent loads, ie. solar panels, are to be installed on this portion of the roof additional structural strengthening is required. See sheet S2.0 for one solution.

2. The attic above the bedrooms and bath where trusses were installed was analyzed (Section C1-C1). While the individual truss members may be adequate in size, the gusset plates at web connections were not adequately sized or properly nailed. The compression and tensile forces acting on the gussets could fail under code anticipated heavy roof snow loads.

INADEQUATE NUMBER OF FASTENERS AT EACH TRUSS MEMBER CONNECTION POINT

EXISTING 3/4" PLYWOOD GUSSET ON ONE SIDE. (GUSSETS SHOULD HAVE BEEN INSTALLED ON EA SIDE WITH A MINIMUM OF 14 NAILS IN THE TOP CHORD AND 14 NAILS IN THE BOTTOM CHORD ON EACH SIDE OF TRUSS. NUMBER OF NAILS INSTALLED COULD NOT BE DETERMINED AS INSULATION COVERED MOST OF GUSSET.)

CEILING BEAM OVER LIVING ROOM (SHOWN IN ORIGINAL DRAWINGS) WAS NOT INSTALLED.

It may be possible to access the attic and install additional gusset plates on the truss web connections and to provide additional nailing. Since access is very poor it would probably be easier to strip the lower edge of the roof shingles and sheathing a couple feet up and install new LVLs (Laminated Veneer Lumber) joists the full width of the attic. These new joists would then be screwed to each existing truss. The drawings show the size and configuration of such joists. This could most easily be accomplished during reroofing. See Building Section 1 Sheet S2.0.

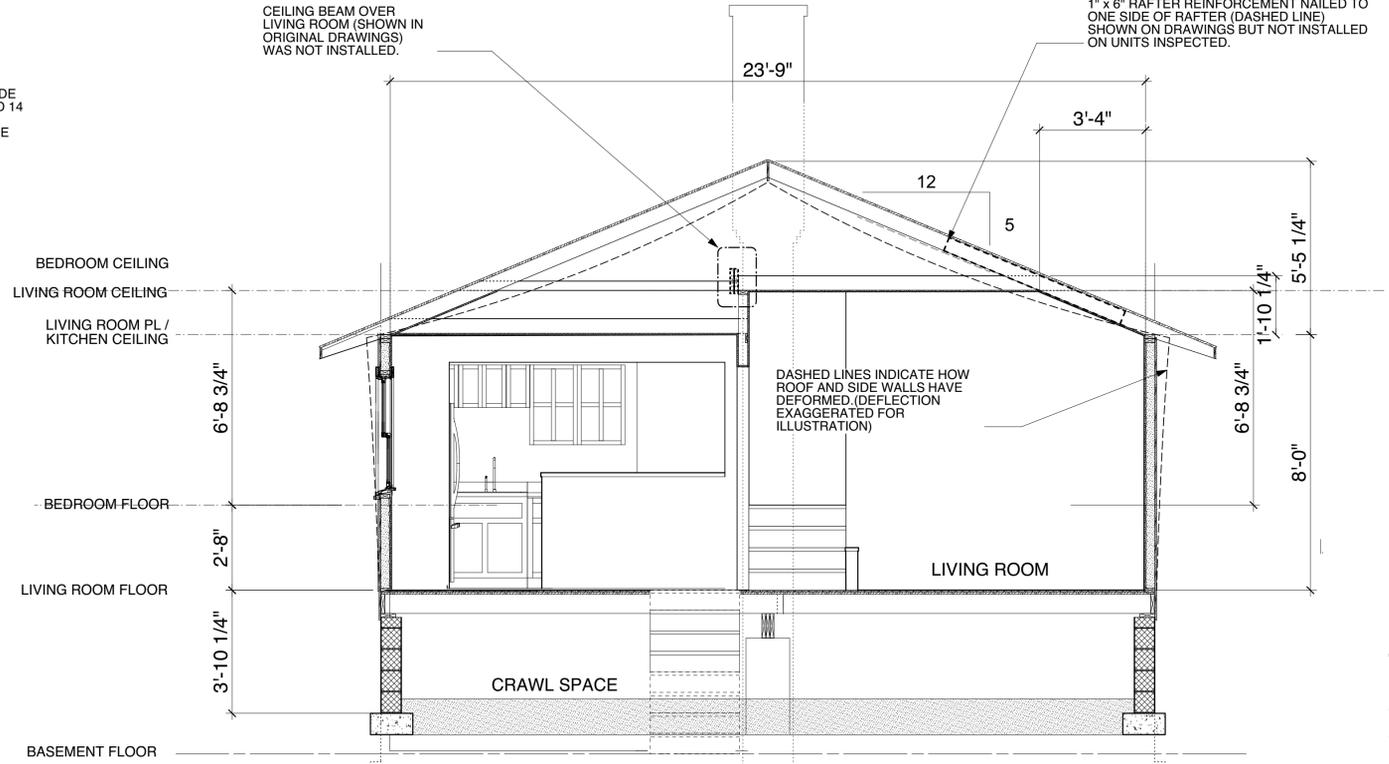
4 EXISTING BUILDING SECTION AT B1-B1
 Scale: 3/8" = 1'-0" on 24" x 36"
 3/16" = 1'-0" on 12" x 36"

1. (Section B1-B1) The living room ceiling and roof assembly consists of 2"x 6" rafters 24" on center tied together with 2" x 6" ceiling joists approximately 1/3 the distance up the rafters. This provides a generous 9' 4" ceiling height in the living room but has introduced severe structural problems by overstressing the rafters.

The ceiling has deflected noticeably downward, (approximately 3/4") in the units inspected. Management has indicated that this is typical throughout the complex. This condition also results in the outward tilt of the exterior walls. Our structural analysis has shown the rafters are severely overstressed where the ceiling collar ties are attached.

A review of the original drawings shows a necessary attic structural beam was not installed in this unit and possibly not in the remainder of the units. The drawings address this problem and how to correct further sagging and rafter overstressing. If Solar panels are to be added to this section of the roof these repairs must be made.

1. The area over the living room is more complex as a beam must be installed by removing a portion of the louvered attic ventilation system and installing a 16 foot long beam under the existing ridge board. Supporting the heavy loads at each end of the beam is harder to accomplish as the walls below the beam's location have openings which makes the transfer of loads to the foundation more difficult. Section 3 on page S2.0 shows how this can be accomplished.

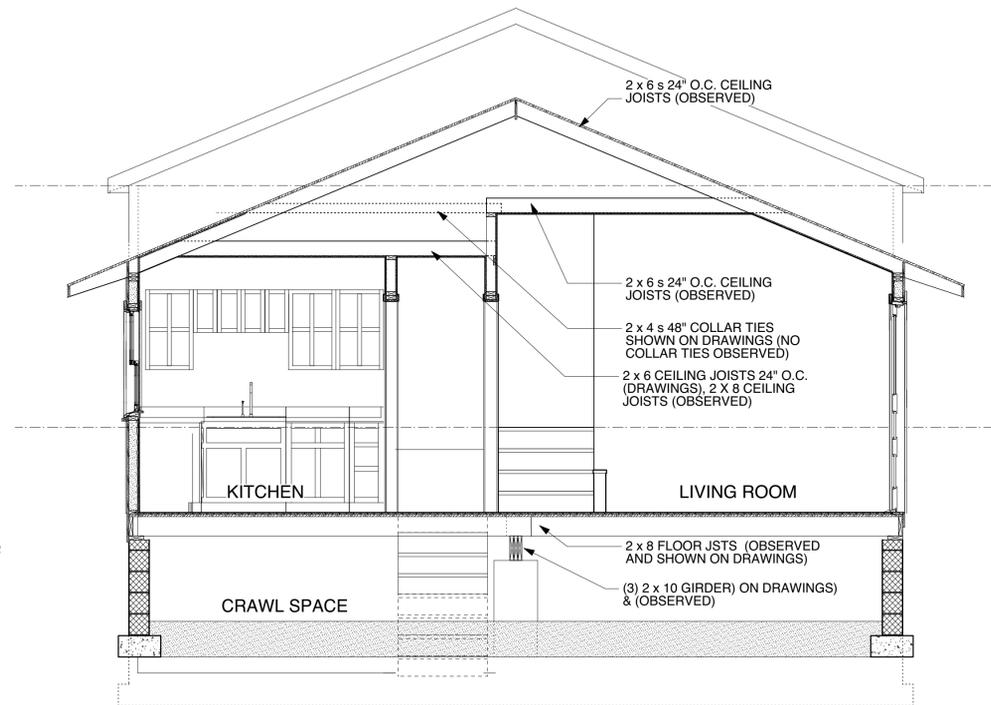
2 EXISTING BUILDING SECTION AT A1-A1
 Scale: 3/8" = 1'-0" on 24" x 36"
 3/16" = 1'-0" on 12" x 36"

2. (Section A1-A1) The dining alcove and kitchen ceiling / roof assembly consists of 2"x 6" rafters 24" on center tied together with 2"x 6" ceiling joists. The joists are approximately 1/3 up the rafters on the dining alcove side and at a lower 8' 0" height on the kitchen ceiling side. The ceiling joists are partially supported by a bearing wall running between the kitchen and dining alcove. This hybrid system imposes lower structural stresses on the rafters but structural problems still are created.

The attic above the kitchen and dining alcove (SECTION A1-A1) is easiest to reinforce. Here, vertical king posts could be installed above the kitchen bearing wall.
