PITTSFIELD VILLAGE COMDOMINIUMS

Structural Alterations to Roofs and Attics to support solar panel installations 2220 Pittsfield Blvd, Ann Arbor MI 48103

ASSOCIATION CHARGE TO CONSULTANTS

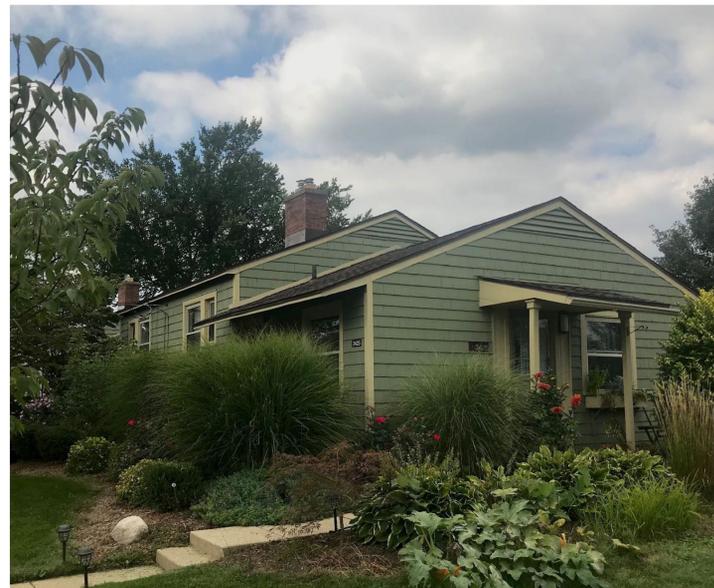
PHOTO ABOVE
One end of a typical four or six unit building. The prominent chimneys divide units. A typical unit consists of a one story living room and kitchen element over a crawl space and one or two bedrooms over a raised basement containing a laundry and mechanical area.

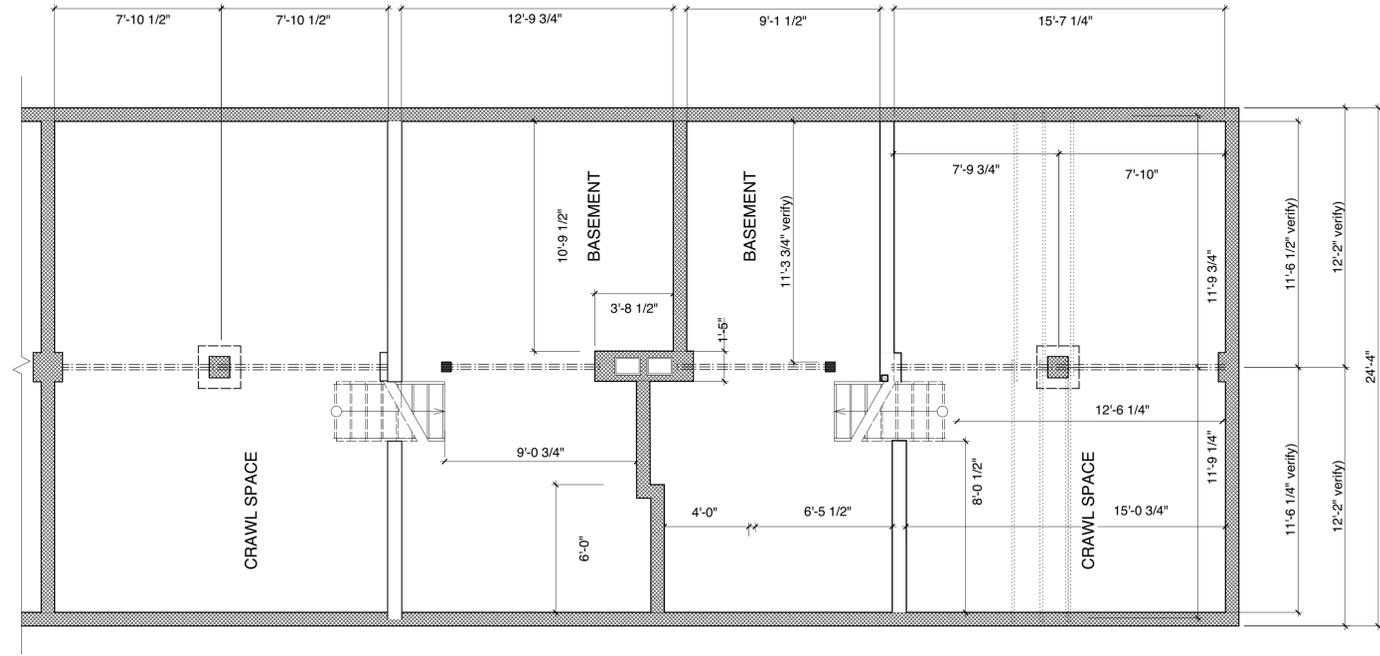
PARTIAL BASEMENT PLAN (EXISTING)
 Scale: 1/4" = 1'-0" on 24" x 36"
 3/32" = 1'-0" on 24" x 36"

NOTE:
 INSPECTION OF SEVERAL
 UNITS INDICATES THAT
 CONSTRUCTION FIELD
 CHANGES WERE MADE FROM
 THE ORIGINAL DRAWINGS

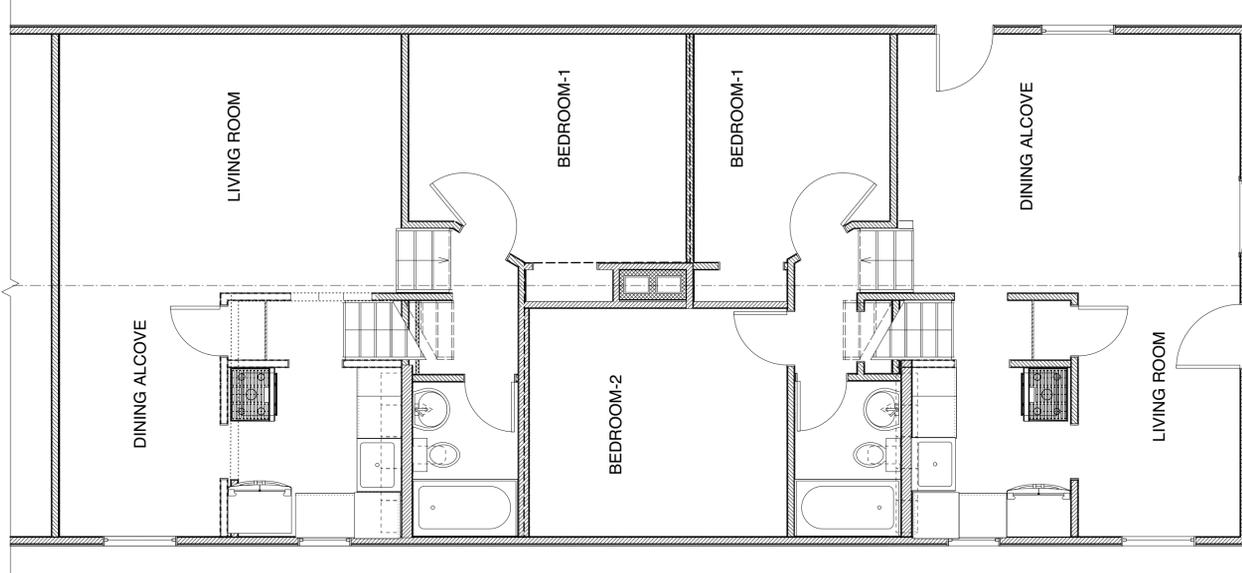
PARTIAL FIRST FLOOR PLAN AND BEDROOM LEVEL (EXISTING)
 Scale: 3/16" = 1'-0" on 24" x 36"
 3/32" = 1'-0" on 24" x 36"

NOTE: INSPECTION OF ONE UNIT INDICATES THAT SEVERAL CONSTRUCTION FIELD CHANGES WERE MADE FROM THE ORIGINAL DRAWINGS

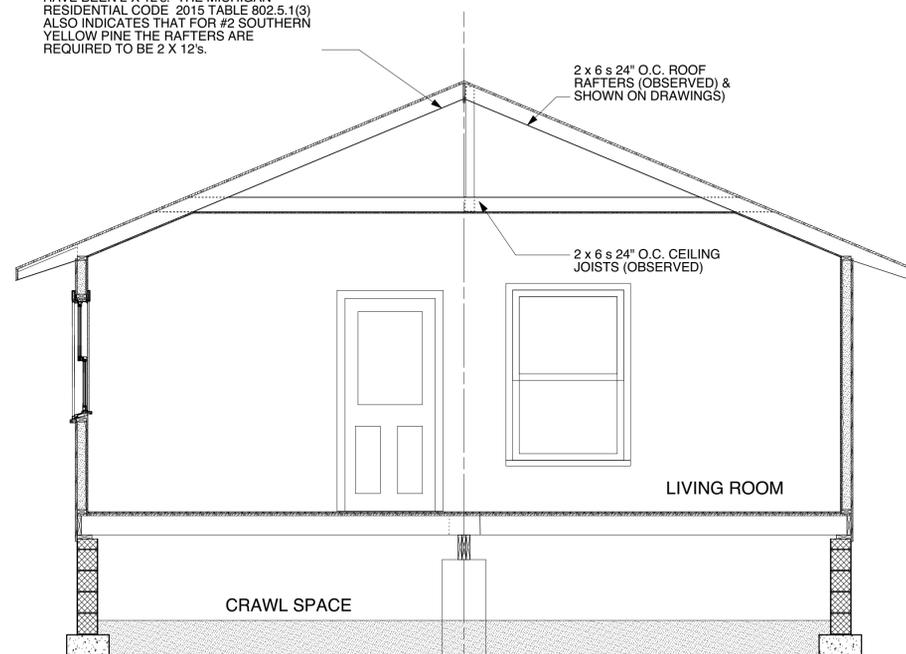
3 EXISTING BUILDING SECTION AT B1-B1
 Scale: 3/8" = 1'-0" on 24" x 36"
 3/16" = 1'-0" on 12" x 36"

STRUCTURAL ANALYSIS SHOWS THAT FOR COLLAR TIES TO BE PLACED AT THE HEIGHT INDICATED THE RAFTERS SHOULD HAVE BEEN 2 X 12's. THE MICHIGAN RESIDENTIAL CODE 2015 TABLE 802.5.1(3) ALSO INDICATES THAT FOR #2 SOUTHERN YELLOW PINE THE RAFTERS ARE REQUIRED TO BE 2 X 12's.
